## OTC-27695-MS

### Heavy Lift Dynamics, Sewol Ferry Offshore Salvage

W.P. Stewart, P. George, and W. Ashley, Stewart Technology Associates, A. Guha, ABS, V. Achanta, Ace Engineers

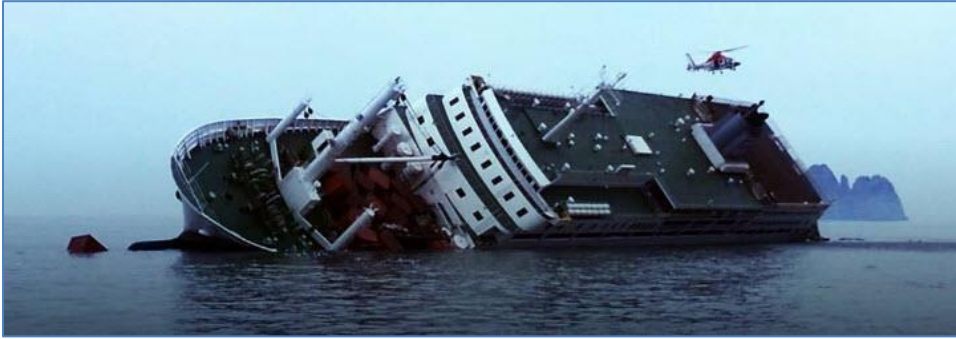
Figure 2 – Sewol Listing and Sinking

The MV Sewol was a RoPax vessel built in 1994. She sank off southwest Korea on April 16, 2014 with the loss of 304 lives, many of them school children. The captain was found guilty of murder. The vessel capsized and sank in 44m water depth, coming to rest on its port side on a level seabed.

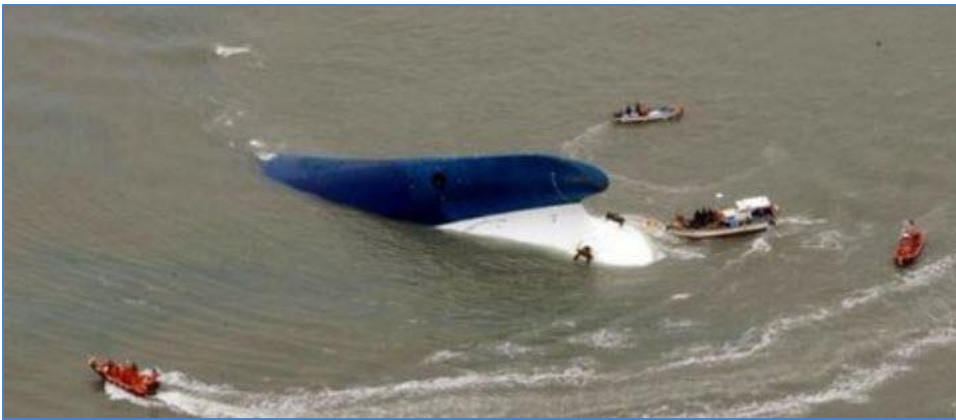
Figure 3 – Sewol Upturned and 98% Below Water

In the final stages of sinking, the vessel rolled onto her port side. Inspections revealed the hull was largely intact with some crushing damage to the port aft superstructure and a severely damaged funnel.

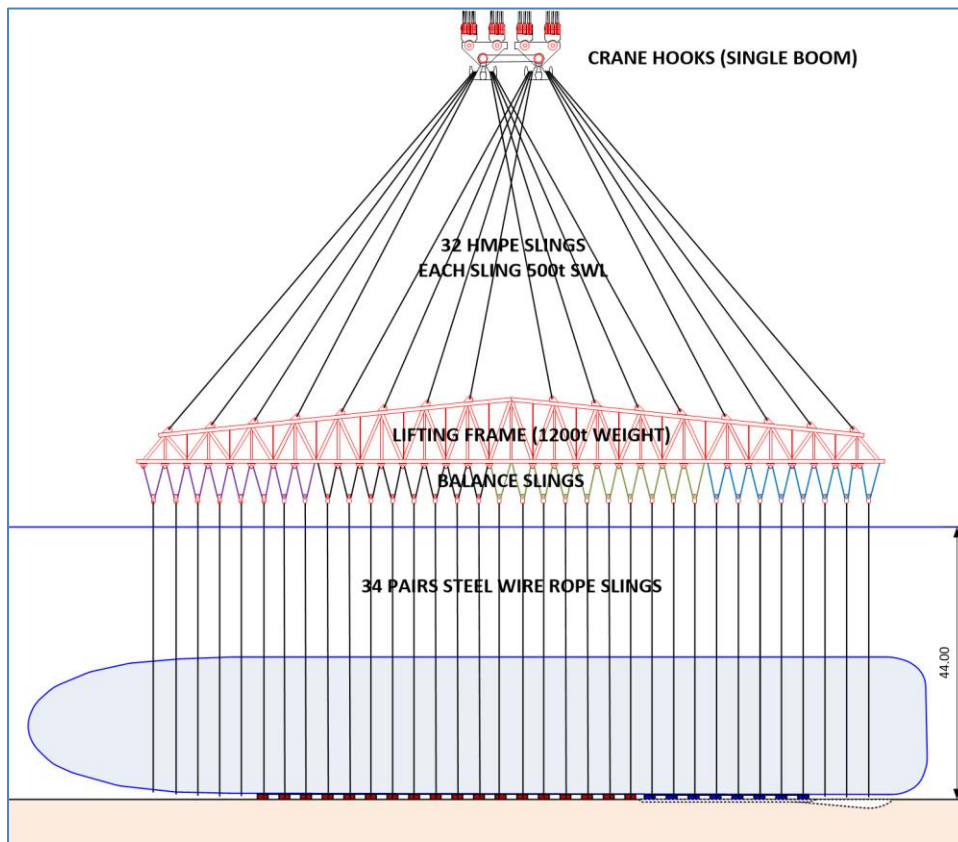
**Figure 7 – Salvage Stage 2A, Rig Main Lifting Frame Supported by HMPE Slings from Crane Hooks**

The balance slings beneath the lift frame accommodate slight differences in the lengths of the steel slings supporting the Sewol. The balance slings also ensure good load sharing between the steel slings.

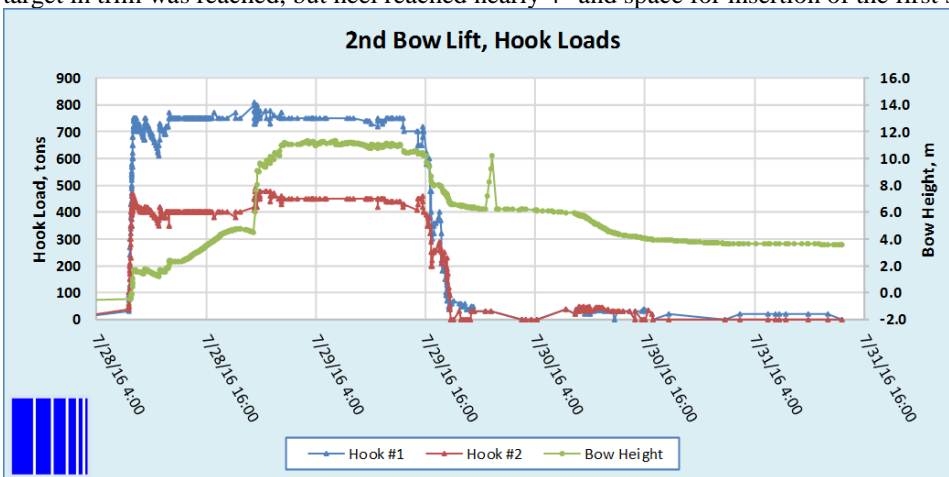
**Figure 10 – Measured Hook loads and Bow Height During Second Bow Lift**

The 2,500t capacity crane barge Dalihao was used for the bow lifts. Each of the two 1,200t main hooks were employed. The bow sling arrangement is described later.

The first set of lifting beams were placed beneath the raised forward end of the Sewol between 4:00 and 16:00 on July 29<sup>th</sup>, before the bow was lowered. The hook loads are seen to reduce to low values after 16:00 on July 29<sup>th</sup>. However, the bow height and trim records show significant changes in value between 4:00 and 16:00 on the 30<sup>th</sup> as the additional buoyancy is modified such that the Sewol is made relatively heavier in water at the bow end. This change in buoyancy was planned to cause the hull to become stable and level on the lifting beams with the stern now raised off the seabed, as shown in Figure 6.

From Table 2 it is seen that the user has specified 225t to be the static load in each of slings 1 and 2. Hence Hook 2 takes 450t. The Excel app calculates 747t to be taken by Hook1. This matches the observed 450t and 750t shown in Figure 10.

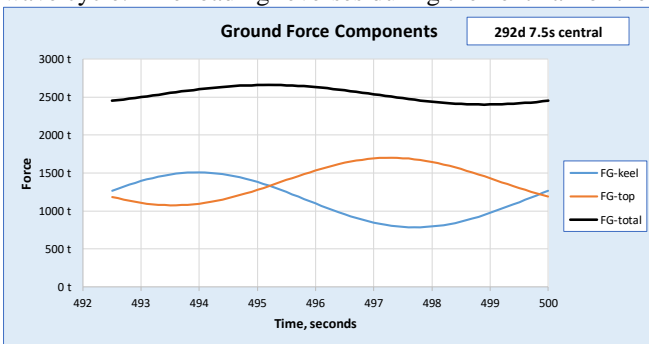
The ground reaction is simulated with the two non-linear soil springs previously described. During passage of a wave the reactions vary. If the wave is in the beam direction relative to the Sewol, the hydrodynamic loads cause a heeling moment and the soil on the keel side becomes more heavily loaded as the soil on the deck side becomes less loaded during one half of the wave cycle. The loading reverses during the next half of the cycle. This is illustrated below.

Figure 24 – OrcaFlex Soil Spring Forces during a wave cycle, 1m wave height, 7.5-sec period

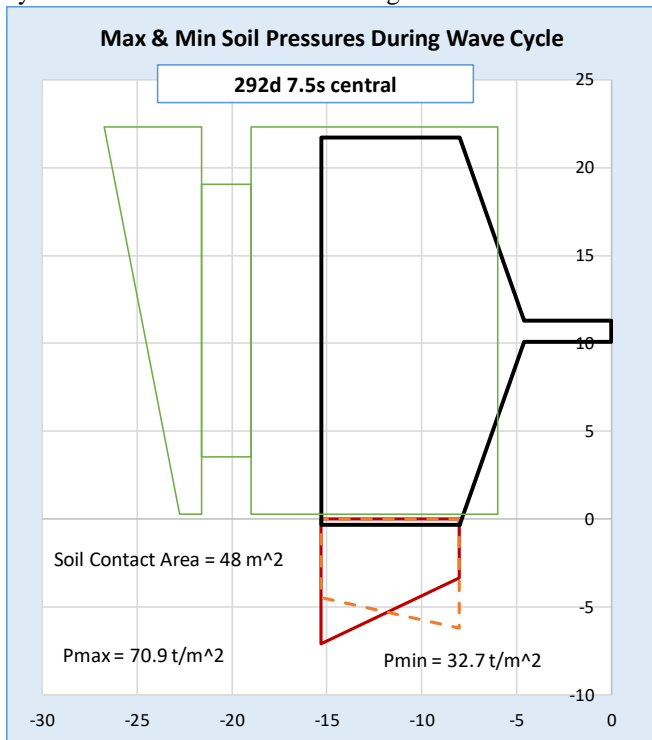
The soil spring forces are converted to soil pressures in the next figure. Only the peak values are shown during the wave cycle. These occur when the heeling moment is at its maximum and at its minimum value.

**Figure 26 - Example of Soil Pressure Variation During One Wave Cycle**

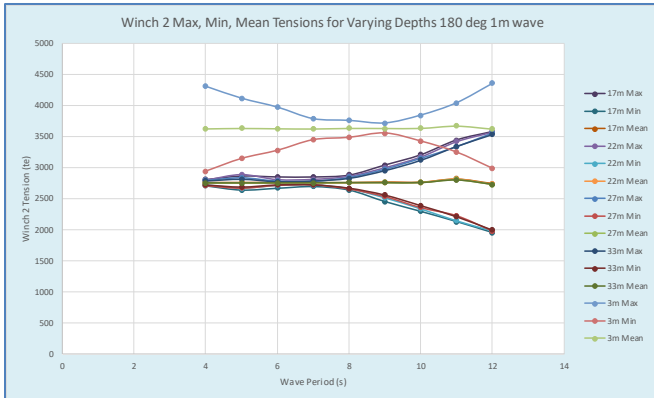
The dynamic responses of the system to waves is complex. There is a tendency for largest dynamic responses to occur at wave period beyond 8 seconds when the Sewol is submerged, but for larger dynamic responses in shorter waves when the Sewol is partly emerged. This is illustrated for one of the two main hook loads shown below for a 1m significant wave height approaching from the 180-degree direction (heading towards the bow of the Sewol and on the beam of the crane).

Figure 30 - Hook 2 Max, Min, Mean Hook Loads, Various Depths, AE=500MN, Waves 1m at 180 deg.

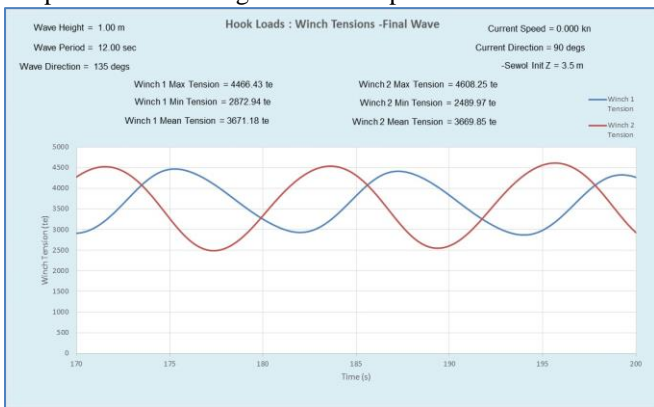
Figure 31 – Main Hook Loads, Sewol Depth 17m, AE=500MN, 1m Wave 135deg, T=12s

In Figure 31, it is seen that the load case results in the main hook load dynamic tension variations being nearly perfectly out of phase.

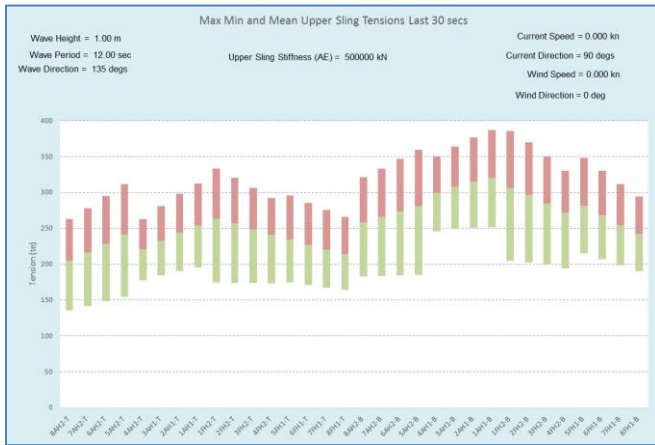
Figure 32 - Upper Sling Tensions, Sewol Depth 17m, AE=500MN, 1m Wave 135deg, T=12s

The maximum and minimum tensions in each of the upper HMPE slings are reported in Figure 32 for the same load case as in Figure 31. The balance sling maximum and minimum values for the same load case are reported in Figure 33.

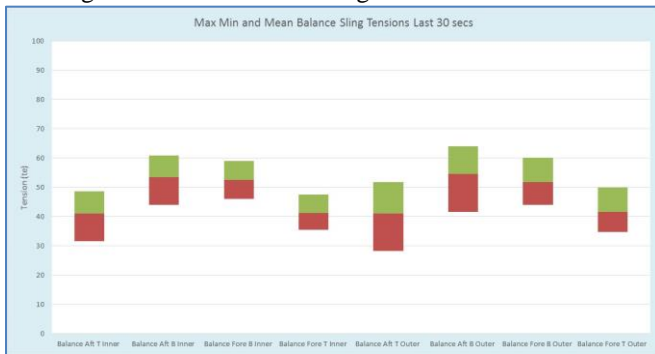
Figure 33 - Balance Sling Tensions, Sewol Depth 17m, AE=500MN, 1m Wave 135deg, T=12s

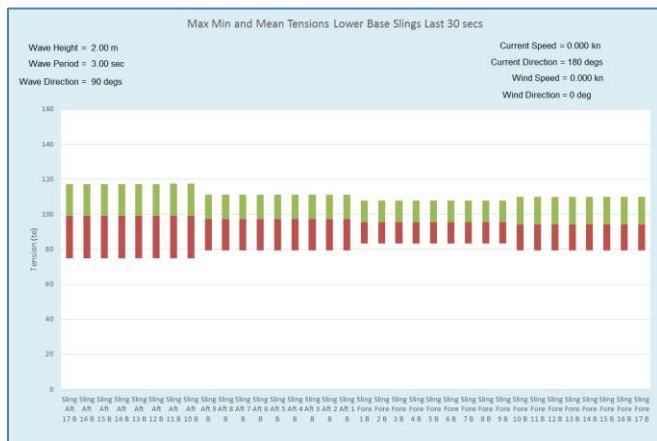
Figure 35 – Lower Steel Slings on Sewol Keel Side, Sewol Depth 17m, AE=500MN, 1m Wave 135deg, T=12s

Figure 34 shows the maximum and minimum tensions in the steel slings below the main lifting frame, on the Sewol topside, for the same load case as in Figure 31. The results for this load case for the steel slings on the keel side are shown in Figure 34.

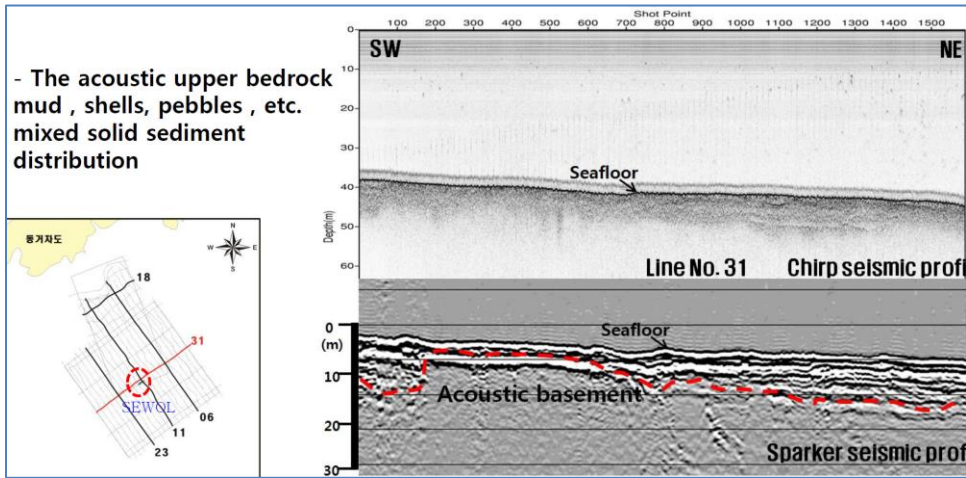
The KIOST sub-bottom profile data closest to the wreck was line 31 which ran parallel to it, and about 40m north; and line 11 which crossed just behind the bows of ship. These lines and KIOST's interpretation are illustrated in Figure 40 and Figure 41. A further line (12) crossed the stern, but no interpretation was given.

Figure 40 – KIOST Line 31

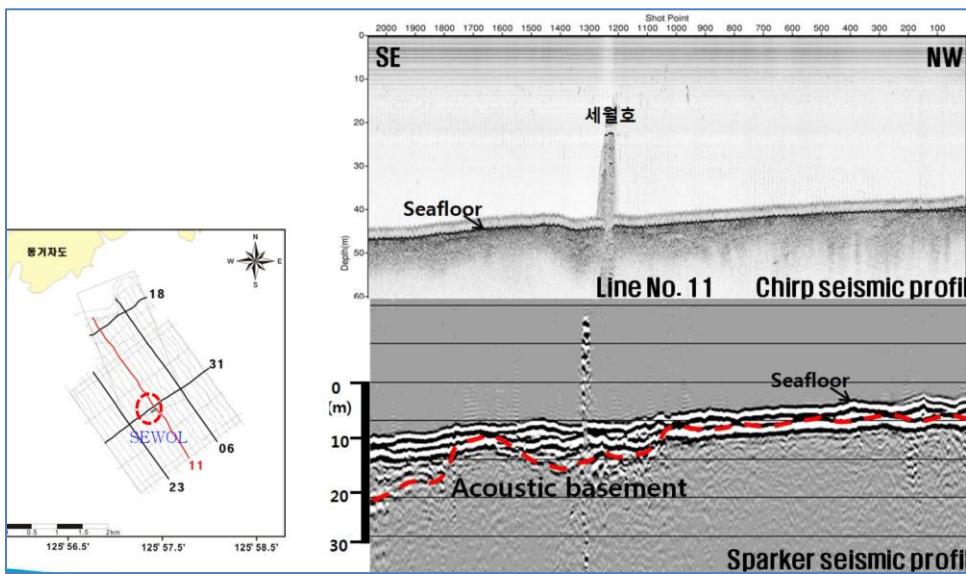
Figure 41 – KIOST Line 11

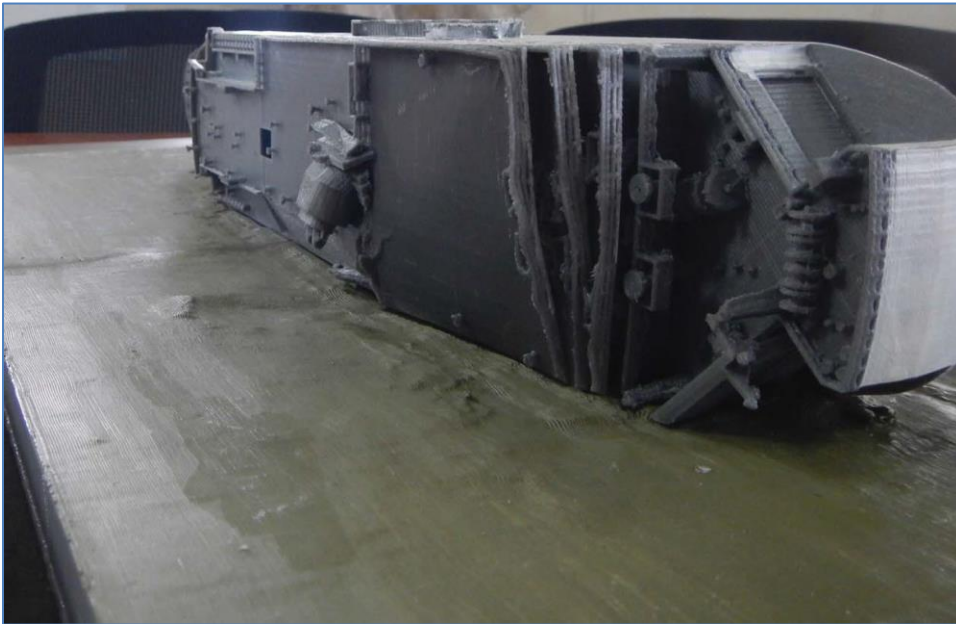
- first impact on the seabed being caused by the port-side stern end of the superstructure (resulting in the collapse of the port side corner of the upper deck. (See Figure 45);
- the second impact and scar relates to the funnel being crushed just before rollover takes place (See Figure 39 above)
- The "funnel scar" lies directly beside where the damaged funnel is now.

**Figure 45 – Sewol 3D Printed Model by KIOST Showing Topside and Adjacent Seabed**

It is speculated that the first impact of the upper deck, the "superstructure scar", is about 20m away from the damage. This suggests that the vessel, under failing buoyancy conditions, drifted ten to twenty metres north east after the first impact. In fact this scar shows two depressions in a line going southeast, suggesting that the damage was caused by two impacts. The vessel was lying in the water, mostly submerged, at an angle of 29° upon first impact.
